Lane Plating Works Superfund Site

Community Meeting November 13, 2018

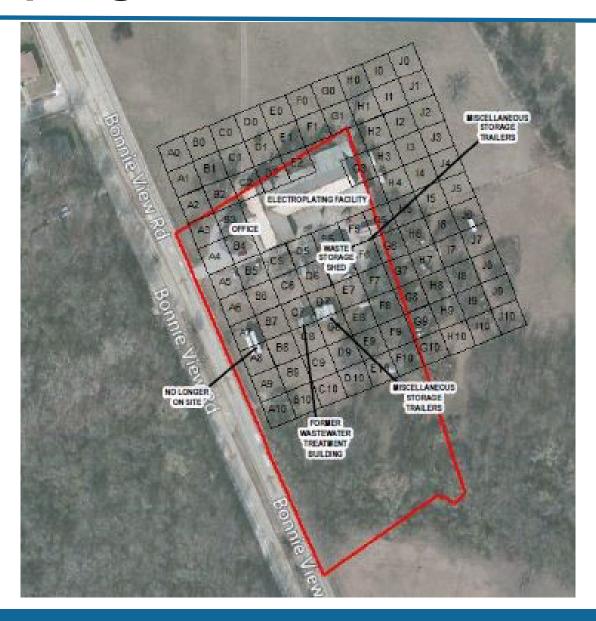
Soil Sampling Grid

- Soil sampling conducted:
 - April 12 13, 2016 (initial Removal Assessment)
 - Sept. 19 23, 2016 (in conjunction with the Removal Action)
- Most common metals detected associated with Lane Plating operations:
 - Hexavalent chromium
 - Lead
 - Mercury

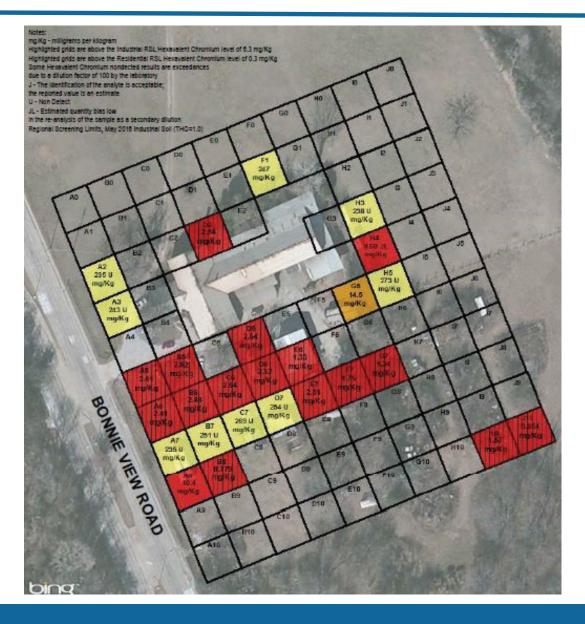
Soil Sampling – Hex Chrome

- Site reconnaissance completed on March 23, 2016
- ► Field activities conducted April 12-13, 2016
 - Liquid waste sampling
 - Soil sampling
- Sample results
 - Liquid wastes are characteristically hazardous
 - Soils are contaminated predominantly with hex chrome, lead, and mercury above EPA Risk Screening Levels (RSLs)

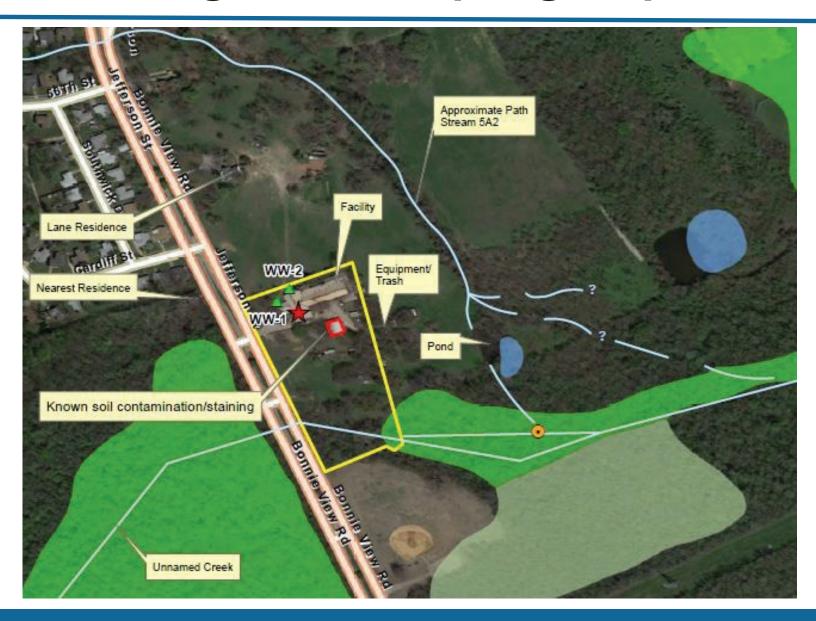
Site Investigation Sampling Map

- Site Visit/Field Reconnaissance conducted on
- ➤ July 18-21, 2018
- Field Activities completed from July 18-21
 - Soil
 - Surface Water
 - Sediment
